FACILITY MASTER PLAN REPORT

for the TOWN OF WILMINGTON

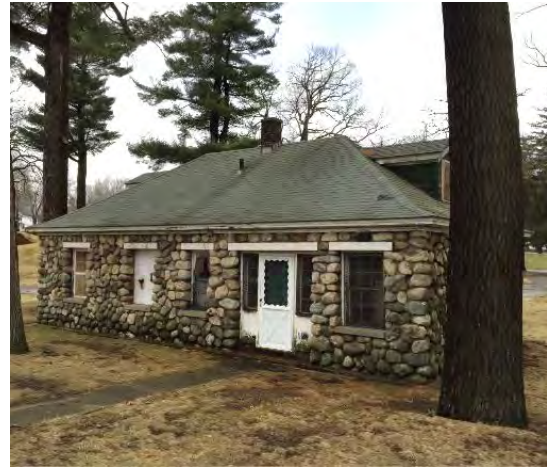
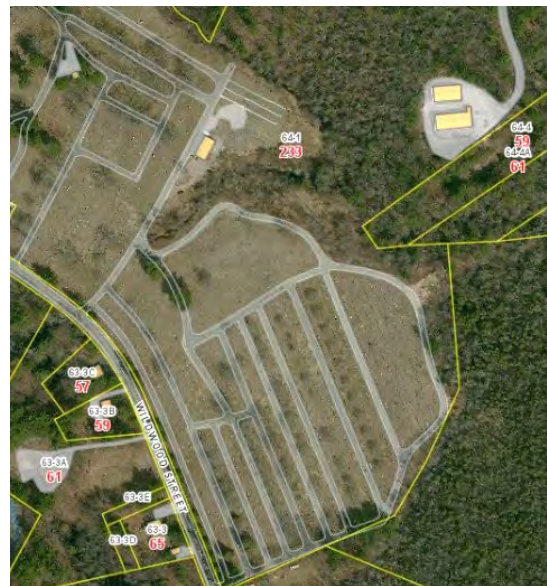
Roof - Exterior fascia and soffit trim require repairs and restoration of eave moldings where they were removed for now abandoned gutter blocking. The asphalt shingled roof was beyond its expected service life when initially observed. However, because recent work has been accomplished on the roof, additional improvements may not be required and have not been assumed. However, this assumption should be verified when specific capital improvement budgeting is advanced for this building.

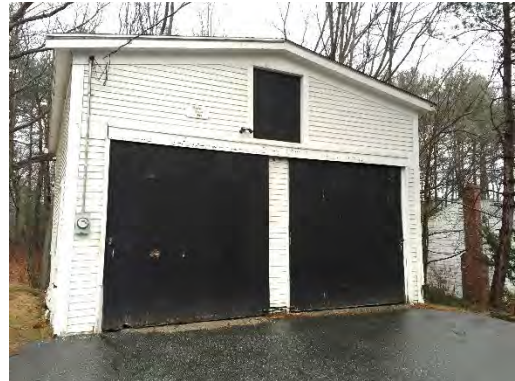
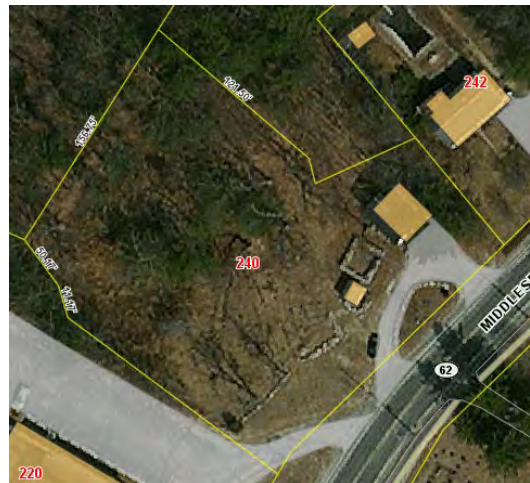
Structure - There is subsidence of the south west side wall evidenced by sloping clapboards flanking the southern-most garage door, this is suggestive of structural deterioration. The structure should be evaluated and any structural damage from rot or movement repaired.

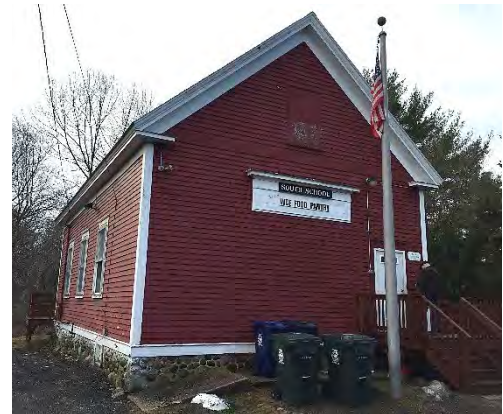
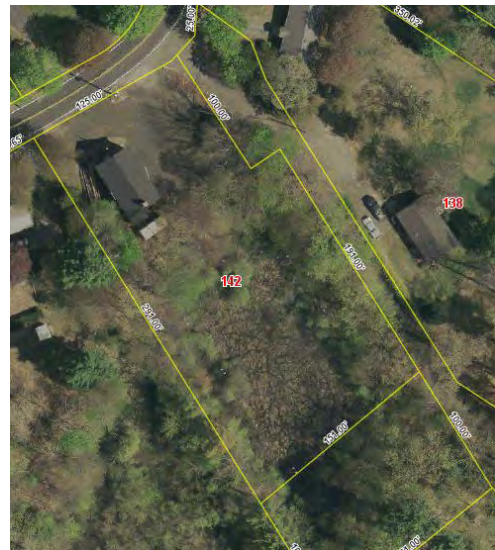
Building Exterior - The entire exterior siding and trim should be refinished including the water table board and cap which have significant deterioration. Attic window openings have been covered with painted plywood, which should be removed and windows installed that are in keeping with the architectural aesthetic of the building. Wood framed window screens have been affixed over three windows on the north-east façade and need repair.

Concrete slab at front façade is heaved and should be repaired. Siding and trim repairs are required on the exterior, especially where it contacts stone foundation. Insulating the exterior walls and attic should be considered during the course of renovation as well as new insulated windows.

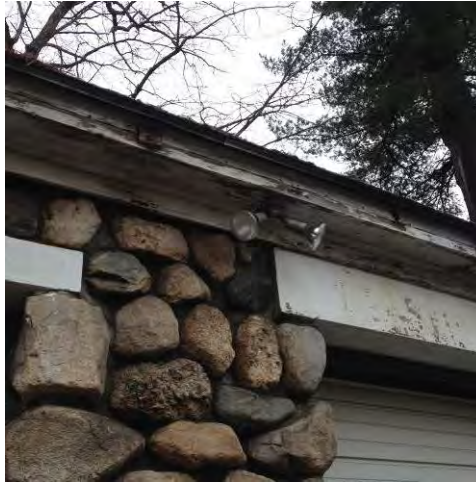
Front Exterior Lights

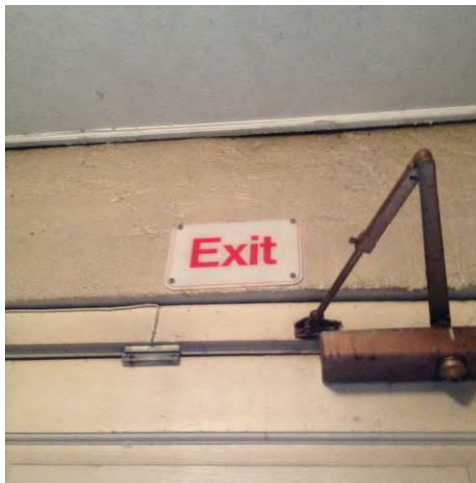
Unlit Exit Sign
