FACILITY MASTER PLAN REPORT

for the TOWN OF WILMINGTON

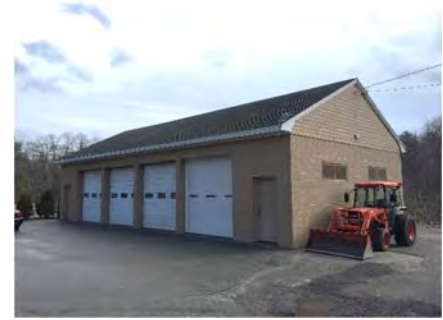
Enhanced vegetative screening around the building is recommended. Water infiltration behind exterior paint finishes suggest special consideration should be given to the selection of future CMU coatings and as most of the infiltration was observed below masonry openings, new windows with integral pitched sills may better protect the wall finishes. Recent improvements include a new roof, exterior paint and electrical upgrades.

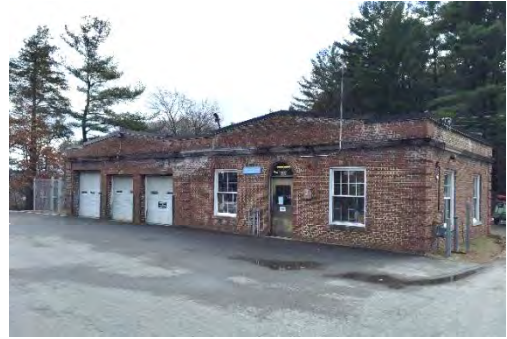
The facility will be demolished and its functions transferred to the DPW Garage site. There are significant constraints on continuing to use and operate this building because of its location on a Zone 1 Aquifer Protection district, and because it is within the 100-year flood plain of Martin's Brook. This has resulted in occasional flooding of the building and site. As reported by DPW, flooding has disrupted operations in the building 3 times in the last 20 years, with disruptions lasting approximately 2 weeks. There are limited options for creating a more flood resistant site and building.

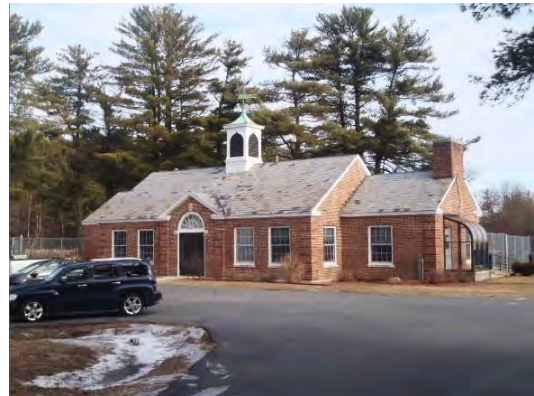
This building is in generally good condition. It is within the 100-year flood plain of Martin's Brook. This has resulted in occasional flooding of the building and site. As reported by DPW, flooding has disrupted operations in the building 3 times in the last 20 years, with disruptions lasting approximately 2 weeks. It is not practical to floodproof the building for the extended periods of time that would be required.

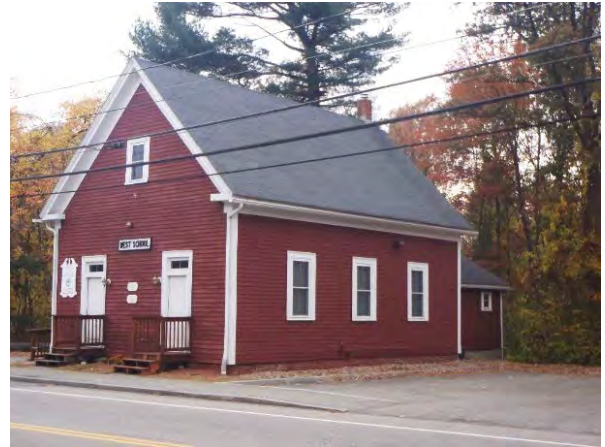
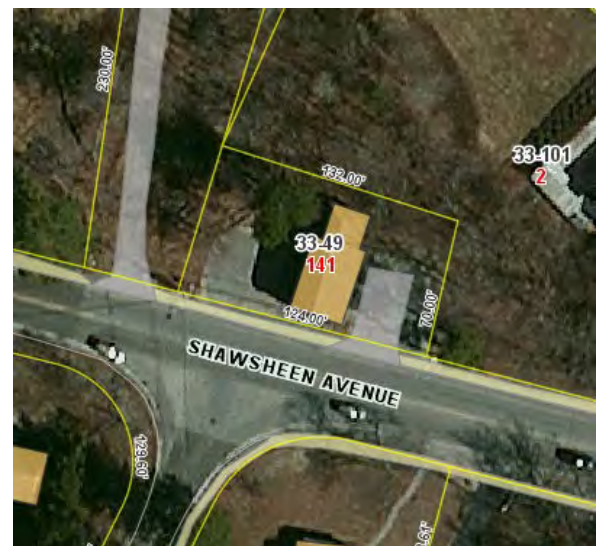
Building Exterior - The structure is generally sound but will require significant upgrades to preserve it for use in the future. The brick chimney in the rear of the building requires pointing. The exterior siding finish is in fair condition, but requires small repairs. Cornices and fascia shadow boards require fastening and sealing, where fuel oil service pipes formerly entered the building, the holes should be sealed and the siding patched. The building is accessible with a ramp servicing a rear entrance. The ramp's railing is subject to movement and requires additional bracing. The ramp leads to a door with a threshold and door hardware that does not meet ADA standards. The hardware should be replaced with lever handles.

Crawl Space - There is a crawl space with a dirt floor below the main floor. An attempt to insulate the floor was made and unsecured insulation is falling away from between the floor joists. Best practice for heating the building and mitigating the effect of ground sourced moisture will include perimeter insulation at the foundation wall and a continuous vapor barrier across the entire space wrapping up the foundation wall and sealed continuously at the base of the sills. The abandoned fuel oil tank in the crawl space should be drained and removed and the gas meter penetration of the masonry foundation wall should be sealed.

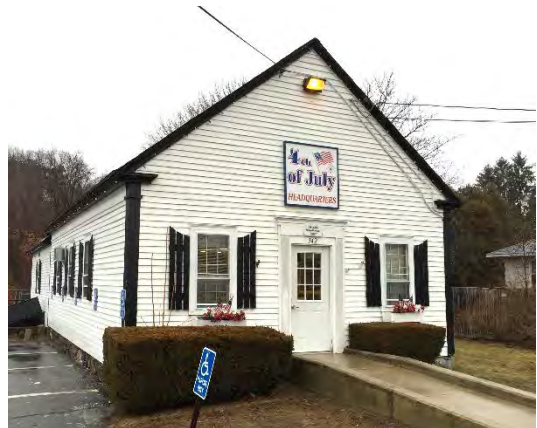
The building will benefit from repair of exterior siding and trim. Other building deficiencies would only require capital improvements if the building was used on a more regular basis and would include accessibility upgrades, life safety lighting and exit signage, a fire alarm, electrical service, wiring and lighting improvements.

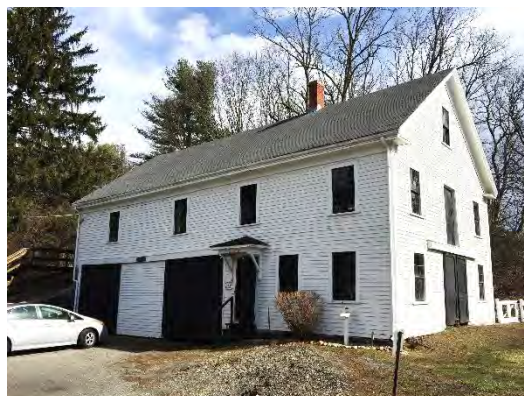
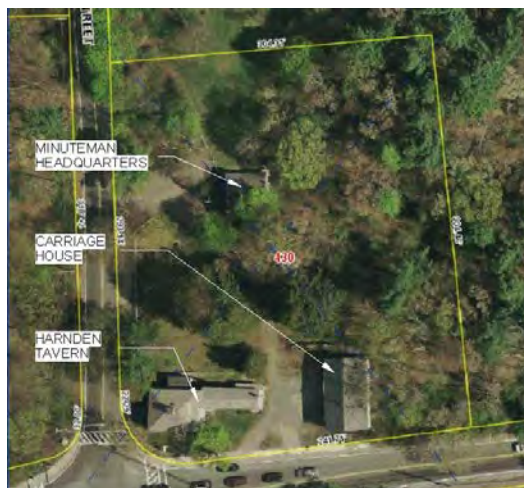
Building Exterior - Significant rot was observed at exterior trim, fascia, and sliding door hardware shrouds should be repaired. The building should be repainted. Exterior siding and trim in direct contact with the ground should be modified to prevent decay.

Site and Landscape - Site improvements should be undertaken to create a more attractive presence. The parking area should be striped as it is currently unstriped asphalt that extends to the building front. An exterior ramp should be provided for handicap accessibility to the front door. Crushed stone drip strips will improve drainage along the south and west facades. Plantings should not be in contact with the building's exterior.

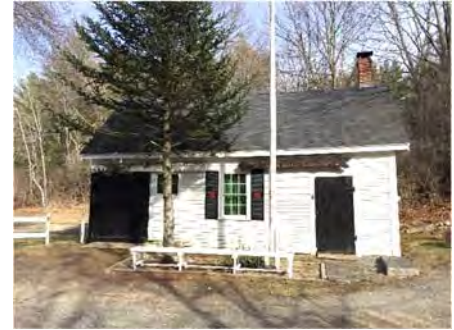
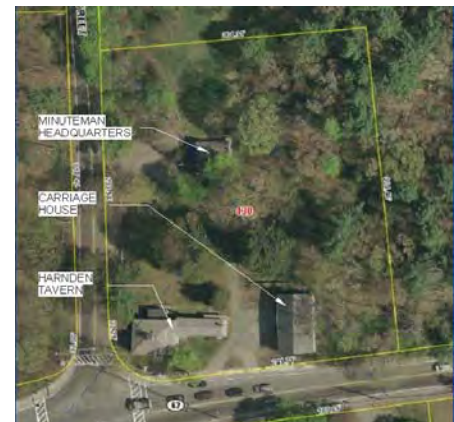
No deficiencies were observed or noted. However, additional observation of the interior conditions should be performed to confirm whether there are interior deficiencies that should be corrected. The building will require periodic painting and may require a new roof, depending upon the age, type and manufacturer of the asphalt shingles currently in place. Fireplaces should be cleaned on a regular basis and installation meets code by confirmation with the Building Official. Responsibility for use and other improvements will fall onto the steward.

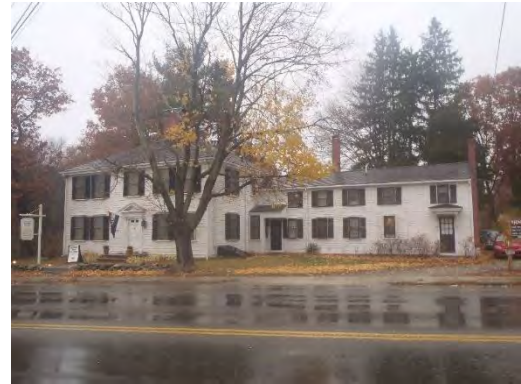
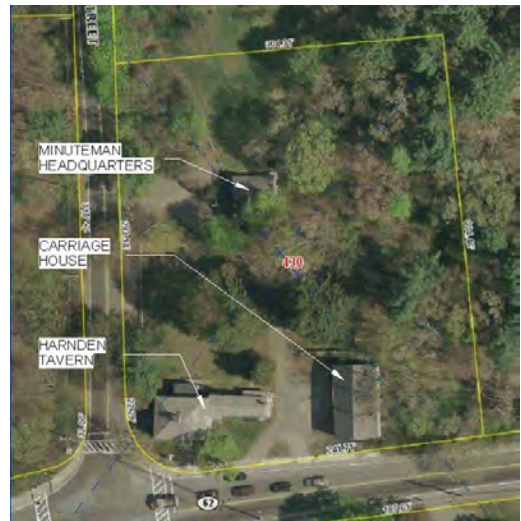
Building Exterior - The facilities gutter drains should be extended further from the foundation line than they currently are.

Building Interior - Some plaster ceilings need repair. In the ell, some plaster cracking on a wall and at adjacent ceiling areas may be due to some structural subsidence that should be investigated in greater detail and repaired. Basement plaster ceilings are in general disrepair and are unsecured in some areas taking surface mounted wiring with them therefore, those ceilings should be repaired or removed, and wiring secured to structure.

Mechanical (HVAC) - Oil fill and vent piping on the exterior should be extended to a serviceable elevation above anticipated snowfall. Programmable thermostats should replace the existing dial type thermostats. Locations where chimney clean-outs are missing should be sealed.

Plumbing - Domestic water lines should be insulated. Original cast iron drainage piping should be replaced.

Electrical - It is recommended that all remaining knob and tube wiring be replaced and or removed. Electrical service upgrade is recommended. Existing service is marginally adequate for current total load. Lighting should be extended to the attic.

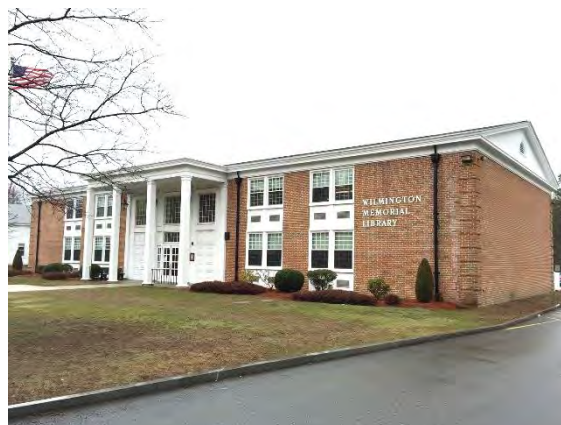
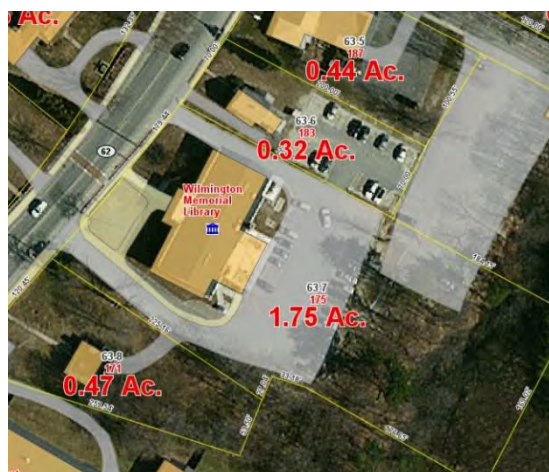
Mechanical (HVAC) - The original boiler is in place and should be replaced. The boiler breaching should be replaced when the boiler is replaced. Boiler combustion air supply is inadequate and needs to be enhanced. Building exhaust is limited and needs to be expanded throughout the facility.

Plumbing - A thermostatic mixing valve and expansion tank needs to be installed at the water heater. Water piping near the tank needs to be insulated. Cast iron drainage piping should be replaced.

Fire Protection - A sprinkler system will be required with an addition. The building area is 14,910 GSF. Compliance with Massachusetts General Law M.G.L. Chapter 148 Section 26G is required in all buildings, in which renovations will exceed 7,500 square feet in area, or if in which major alterations are planned. Under these conditions an existing building must provide a full sprinkler fire protection system if sufficient water flow is available. A hydrant flow test, is required to determine adequate capacity for fire protection.

Electrical - Emergency lighting and exit signs need updating. Fire alarms, horn strobes, pull stations, and smoke detectors do not provide an appropriate amount of coverage for a non-sprinklered building, and will need to be re-evaluated with an addition, which will require that the building have a sprinkler system. The existing electrical equipment is beyond its useful life. The emergency standby generator, is due to be replaced. There is no separation of life safety equipment, and optional standby.

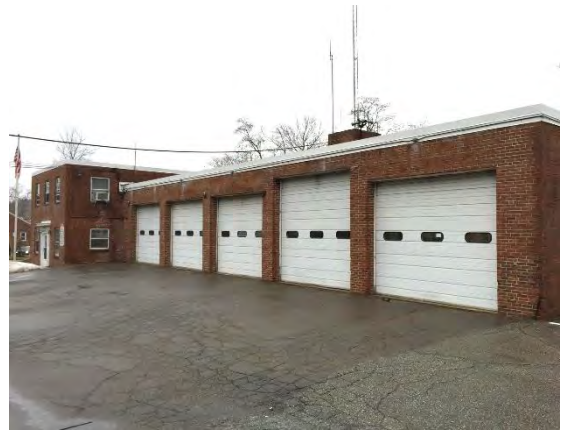
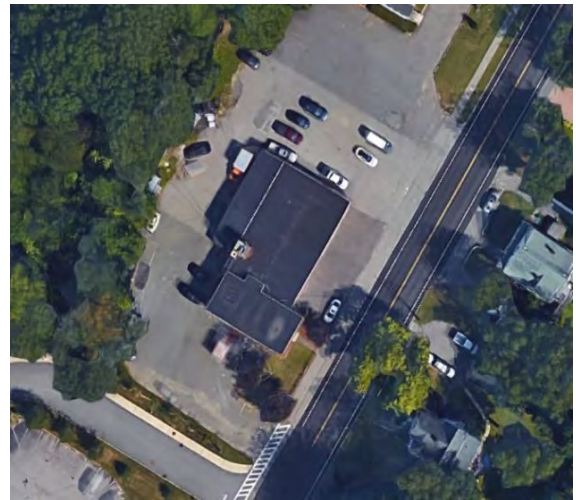
Site and Landscape - A walkable route from the parking area to the main entrance in the front of the building needs to be provided. The parking area needs better defined parking spaces with handicapped parking identified. Signage that defines parking areas would improve site circulation and eliminate confusion.

Building Exterior - The brick masonry façade requires repointing throughout with the greatest need at the back of the tower and at window openings. Garage windows are in poor condition and should be repaired or replaced. Wood window bucks around replacement window openings need to be painted. Wood trim at the main entrance is in need of repair. An abandoned flue penetration on the northeast façade needs to be covered or sealed on the exterior.

Building Interior - The interior finishes are generally in fair to poor condition and should be updated. The upper level kitchen flooring is in very poor condition and needs to be replaced. Interior level transitions are not compliant with current accessibility standards, and require upgrades. Toilet rooms should be upgraded to achieve current accessibility standards.

Plumbing - Domestic water pipes should be insulated and labeled. A thermostatic mixing valve should be installed at the outlet of the water heater. An expansion tank should be installed at the cold-water make-up for the water heater. Cast Iron drainage piping is in poor condition and should be replaced. Horizontal storm drainage piping should be insulated. The garage has floor drains that should be directed to an oil/gas separator.

Electrical - Electrical systems are generally in poor condition. Abandoned electrical wiring including a service entrance on the exterior of the building and it should be removed and penetrations in finish systems should be patched. Emergency lighting and exit signage is insufficient and needs updating. The fire alarm system should be updated to provide coverage for the building. The life safety equipment and the optional emergency standby power system should be separated.

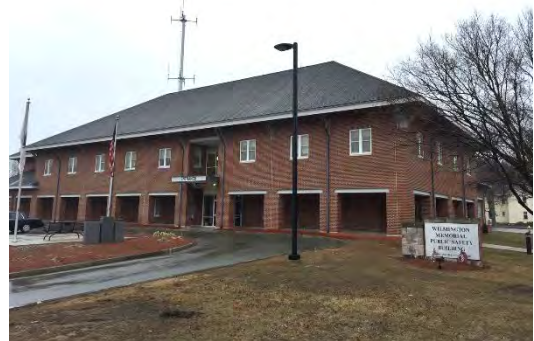
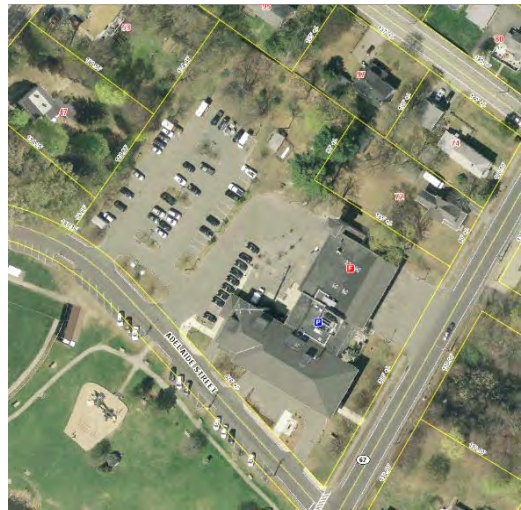
Building Exterior - Drywall soffit at the public entrance is failing and needs to be replaced. Air/vapor barrier in the attic needs to be repaired, as it is not continuous or sealed.

Mechanical (HVAC) - Laboratory ventilation is inadequate and needs to be improved.

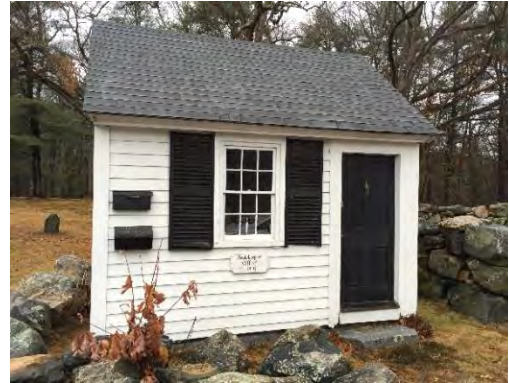
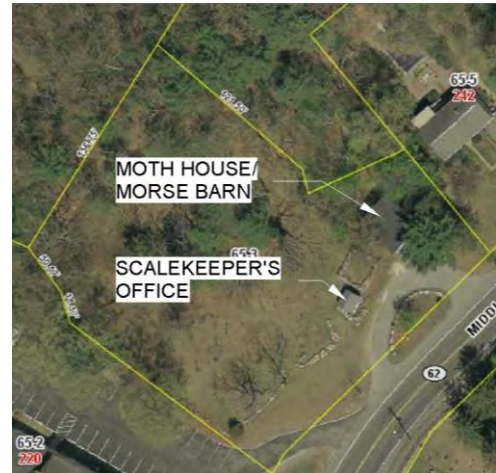
The building is in generally good condition. Other than periodic maintenance level improvements, there are limited additional requirements. It has been noted that the electric power line that extends from the adjacent Moth House/Horse Barn is in poor condition and would be advisable to be replaced.

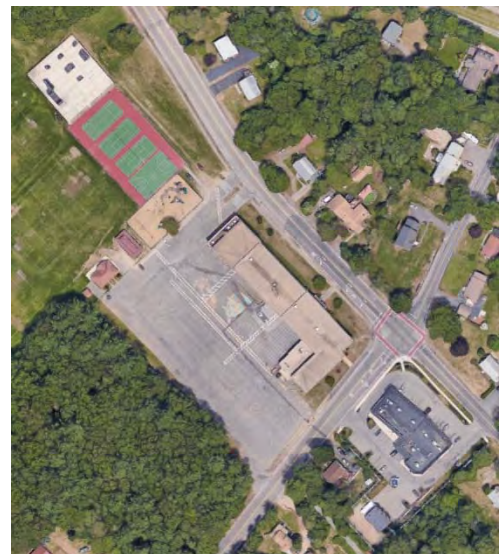
Site and Landscape – The building is very close to Shawsheen Avenue which is a busy thoroughfare. The formal Main Entrance is on Shawsheen Avenue and does not face the parking and bus drop-off area which creates a potential supervision and security issue. The bus loop and the car parking systems are not separated for safety. The school has adequate parking with about 90 spaces, plus playfields and a playground. There is a large paved play area directly adjacent to the school. There are five overlapping playfields, three public tennis courts and a basketball court on campus. The fields are worn and drainage is poor. They should be reseeded with improved drainage.

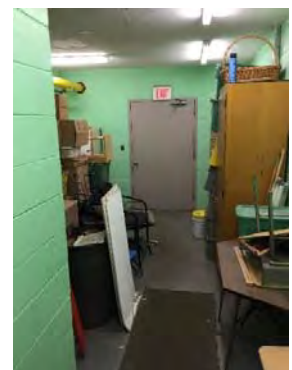
The Shawsheen School has a significant egress issue at the lower (A) level. An exit sign within a corridor leads into a storage room which has a marked exit door at the other end. This second door swings inwards, not in the direction of egress, and does not have panic hardware, both of which are standard requirements for egress routes from buildings. As a storage room, the exit path could be blocked by stored materials.

The exiting requirements for this portion of the building should be reviewed to provide either an alternate path or upgrade this path to meet appropriate current building code standards. It appears likely that the exit path can conform to code requirements, for example, by removing the door shown in the photograph and converting the room to serve as a corridor by removing the stored items.

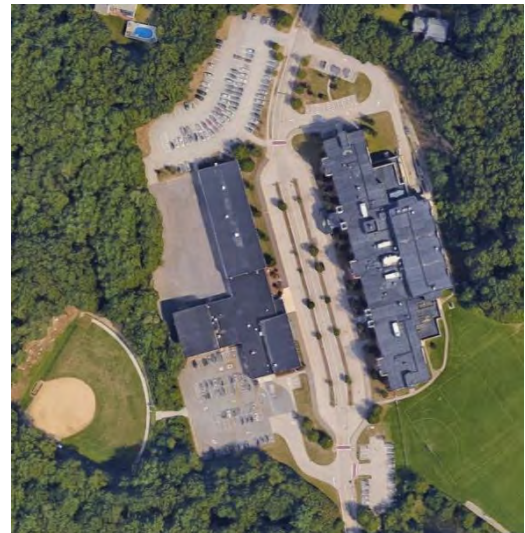
Site and Landscape – The West Intermediate School is located directly adjacent to and facing the Middle School (WMS). An access road separates the bus drop-off lanes for each school. The West Intermediate School bus drop-off is well separated from the parking areas for safety. Parking is shared between West Intermediate and the Middle School with a total combined count of about 205 spaces. The parking is not adequate if there are simultaneous events at the schools. There is a large paved play area directly behind the school. There is a softball field behind West and a baseball and soccer field next to WMS across the access road. There is no playground equipment area.

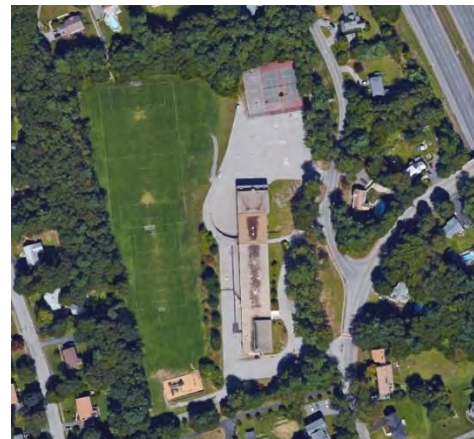
Site and Landscape – The formal main entrance faces Woburn Street but the parking is located at the left side and rear of the school which creates a potential supervision and security issue. The bus loop and the car parking systems are well separated for safety. The school appears to have adequate parking at the rear and the south side, although the spaces are not marked in all locations. There are two large playfields, a playground, and a large paved play area directly adjacent to the north of the school. There are two public tennis courts and a basketball court on campus.

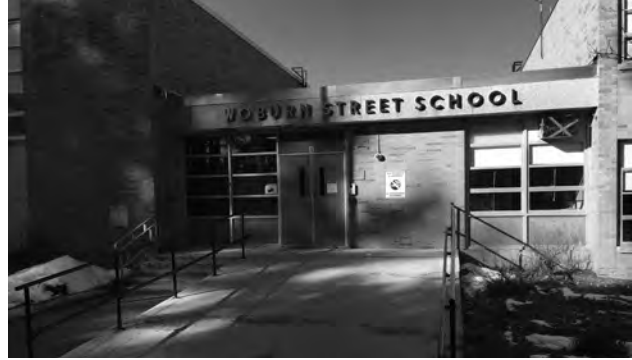
The Woburn Street School is a brick building that serves grades 1, 2, & 3 for roughly 400 students. It is located west of Interstate 93. Solid original construction have kept this facility in fair condition but deferred maintenance and lack of space have put substantial pressure on the facility. The main entrance to the school is off the bus loop area on High Street. Building identification is letter signage on the fascia over the main entry but is difficult to see.

The building exterior consists of a brick façade in good condition, a precast masonry panel at glazing zones in good condition, and metal windows and doors in poor condition that are in need of replacing. The roof is a combination of ballasted and EPDM broken into several sections. The original classroom wing is in the worst condition and the gym roof is in the best. Areas that have not been recently reroofed will require replacement in the near future.

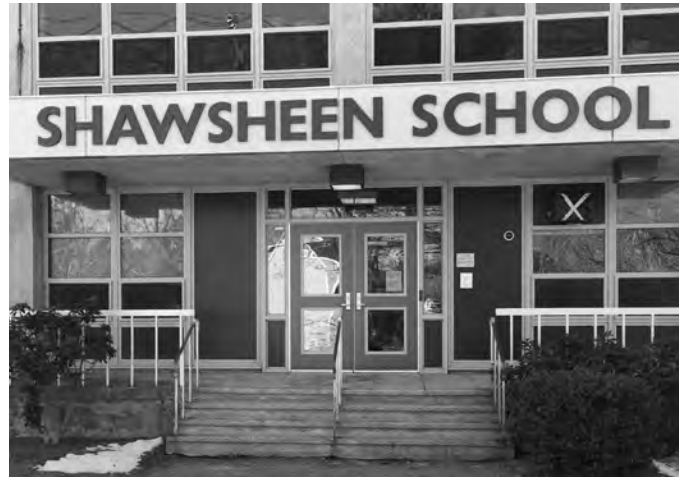
The Shawsheen School is a brick building that serves grades 1, 2, & 3 for roughly 350 students. It is located at the intersection of Shawsheen Avenue and Hopkins Street. Solid original construction, and recent building upgrades have kept this facility in good condition. This building has benefitted from the most upgrades of any of the six schools in the study. The main entrance to the school is directly off Shawsheen Avenue. Building identification is letter signage on the fascia over the main entry which cannot be seen from Hopkins Street or by those approaching from the south.

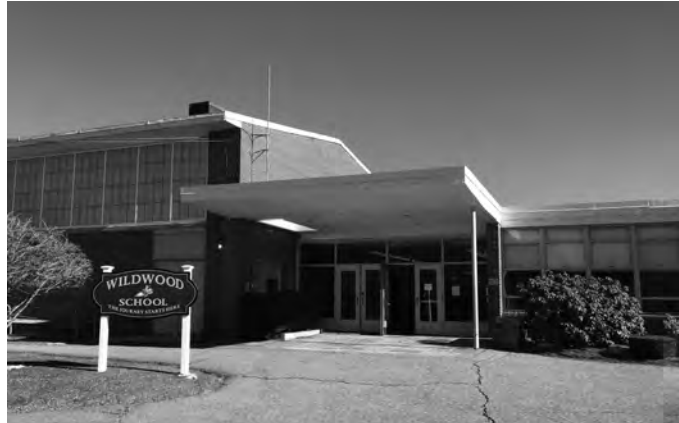
The Wildwood Early Childhood Center is a masonry building that serves grades Pre-K and K for roughly 165 students. It is located relatively close to Wilmington High School which is to the northwest. This facility is the oldest building owned by Wilmington Public Schools. Its age has created a long list of exterior and infrastructure upgrade requirements. The main entrance to the school faces Wildwood Street but is set back and is at a higher elevation than the street. Building identification is ground mounted signage next to the main entry and a sign mounted to the façade of the cafetorium / gym.

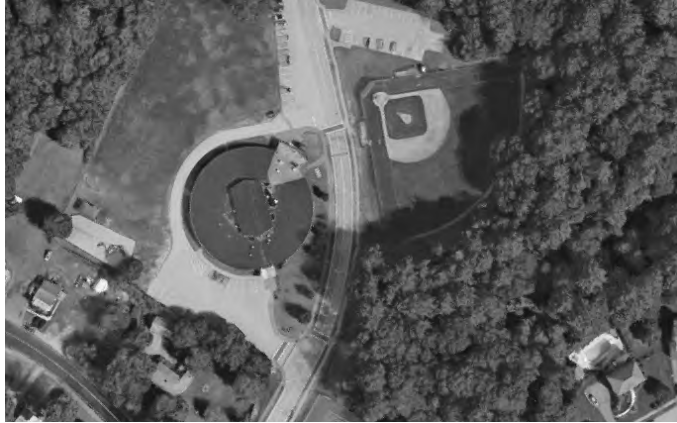
The Boutwell Early Childhood Center is a masonry building that serves grades Pre-K and K for roughly 165 students. It is located to the south of the Wilmington Middle School and West Middle School. Solid original construction have kept this facility in fair condition but deferred maintenance has created a long list of exterior and infrastructure upgrade requirements. The main entrance to the school is immediately off the parking lot at the end of Carter Lane. Building identification is ground mounted signage next to the parking lot entry.

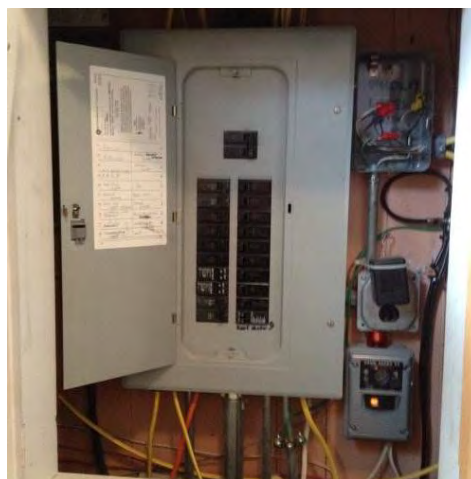
- The electrical service runs overhead between the utility pole and the utility meter mounted on the exterior of the building. The service is rated at 100 Amperes, 120/240 Volt, 1 Phase, 3 Wire. A 100A/2P main circuit breaker GE load center is located in the vestibule. Wiring method consists of Romex.

Main Panel in Vestibule

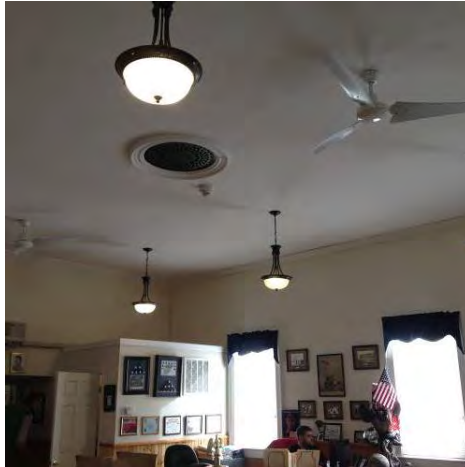
- The interior lighting consists of pendant luminous bowls with three compact fluorescent lamps in the main hall controlled with local switches. 1x4 surface wraparound acrylic lensed fixtures with T8 lamps exist in the kitchen and toilet rooms. Toilet room fixture and exhaust fan are controlled with one common switch. Crawl space has porcelain sockets.

Main Hall Lighting

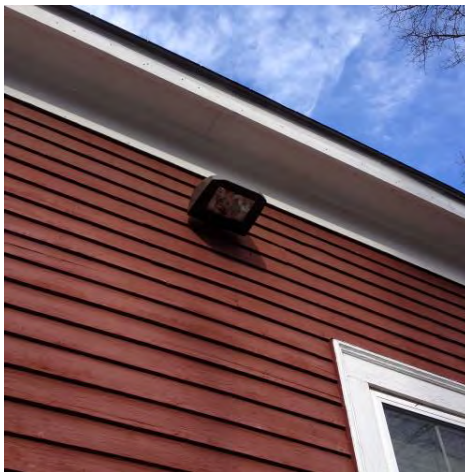
- The exterior lighting consist of building mounted HID wall sconces for the parking areas. Wall sconce lantern fixtures with screw-in compact florescent lamps exist at front door. Exterior lights are timeclock controlled.

HID Wall Sconce

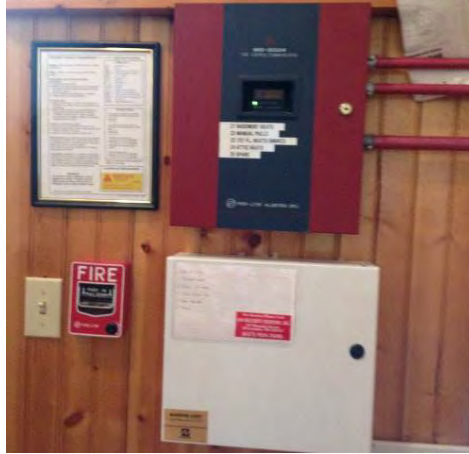
- The fire alarm system consists of a Fire-Lite MS-5024, 5 zones control panel located in the vestibule with a digital dialer. Smoke detectors exist in each space. Heats exist in kitchen, crawl space and attic. Pull stations exist at exterior doors. Notification consists of horn/strobes. A 5 zone LED annunciator and strobe are located on exterior front. The wiring method consists of low energy cable.

FACP & Security Panel

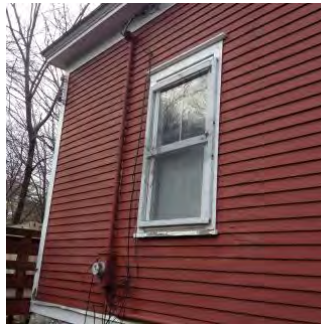
- There is no fire alarm system or security intrusion system.
Rating: N/A
- Kitchen receptacles are not GFI protected.
Rating: 0
- The general wiring method is Romex with some MC cable.
Rating: 2
- The telephone & CATV wiring runs overhead between the pole and the building. The CATV wiring is dead ended near the electric meter.
Image 4 – Exterior Meter and CATV Wiring

Rating: 0

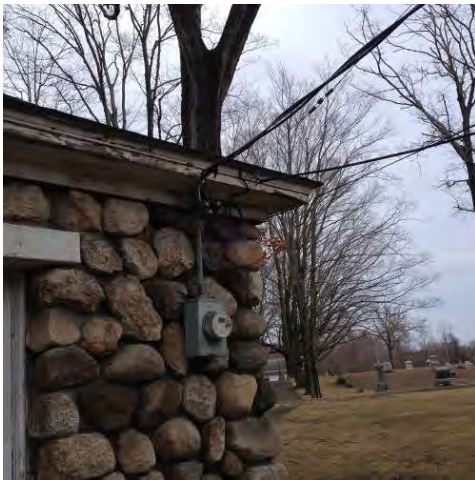
- The electrical service runs overhead between the utility pole and the building mounted meter. The electrical service is rated at 100 amperes, 120/240 volts, 1 phase, 3 wire. A fusible disconnect switch and load center and sub-load center is located high in the garage wall.

Rating: 1

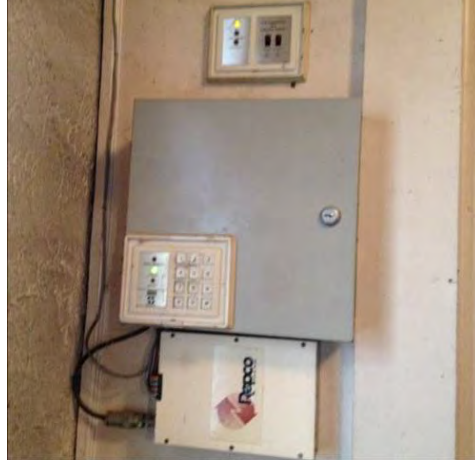
- The fire alarm system consists of a one zone Repco control panel located in the hall. Heat detectors are located in each space. There are no horn/strobes.

Fire Alarm & Security Panels in the Hallway

- The intrusion system consists of a Repco control panel with a keypad in the hallway. A passive infrared sensor exists in the office. The exterior doors have magnetic contacts.
Rating: 1
- Garage overhead doors are not powered.
Rating: 1
- The garage receptacles are not GFI protected.
Rating: 0
- The telephone & CATV service cables run overhead into the building.
Rating: 4

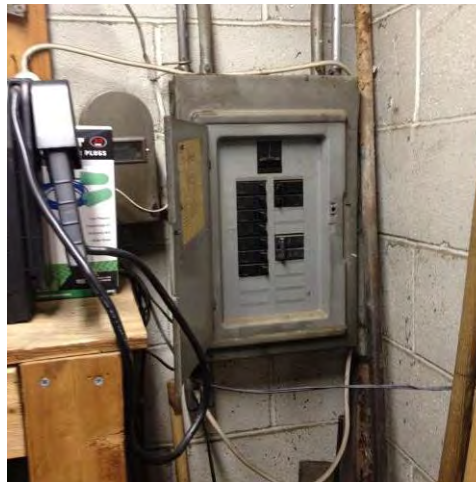
- The electrical service and telephone service run overhead between the utility pole and the building. The electrical service is rated at 100 amperes, 120/240 volts, 1 phase, 3 wire. A 100 ampere, 120/240 volt, 1 phase, 3 wire main breaker, 20 pole panelboard, half full is located in the garage. The wiring method is generally pipe and wire in the garage and Romex in the attic

Rating: 1

Panelboard

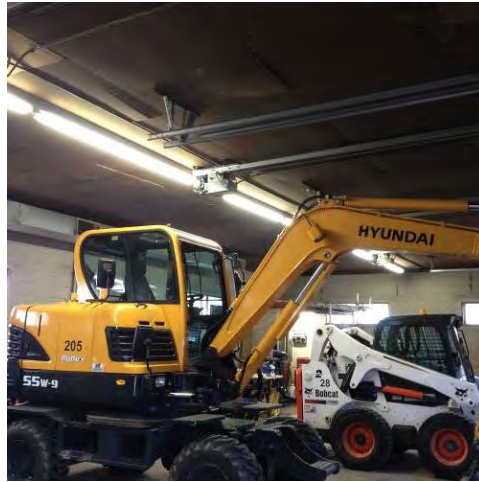
- The interior lighting consists of a single row of 8' strips with T12 lamps controlled with a local switch. Garage is poorly lit. Attic has porcelain sockets on a local switch.

Rating: 1

Interior Lighting

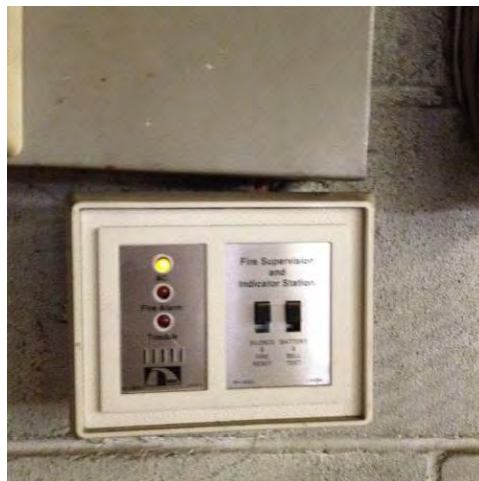
- The exit signs are unlit. There is no internally lit exit signs or emergency lighting.
Rating: N/A
- The exterior lighting consist of par holders without lamps at each corner of the building. There are no lights over the garage doors.
Rating: 1
- The fire alarm system consists of a Napco one zone control panel with old style heat detectors in the garage and attic. The form of transmission is via the same dialer as the security panel.
Rating: 1

Fire Alarm Control Panel

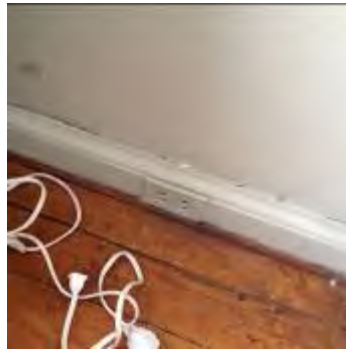
- Receptacle coverage is minimal. Receptacles on wooden baseboard are of the two-prong, non-grounding type.

Rating: 1

Non-Grounding Receptacles

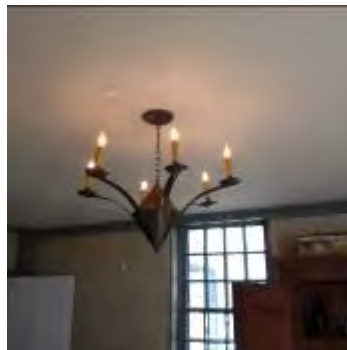
Pendant Fixture

- The interior lighting consists of decorative pendant fixtures and matching wall sconces with candelabra lamps. Other utility fixtures with incandescent lamps are located throughout. The basement has porcelain sockets and wraparound fixtures with acrylic lens. The attic does not have lights.

Rating: 2

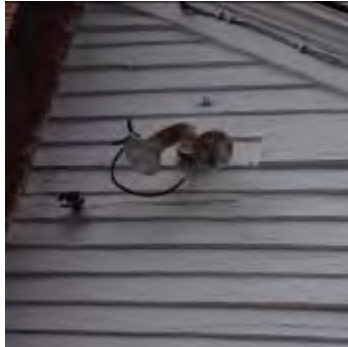
Par Lamps

- The exterior lighting consists of twin par lamp holders with halogen lamps with motion sensor for parking area. Wall sconce lanterns with incandescent lamps exist at exterior doors controlled with interior switches.

Rating: 1

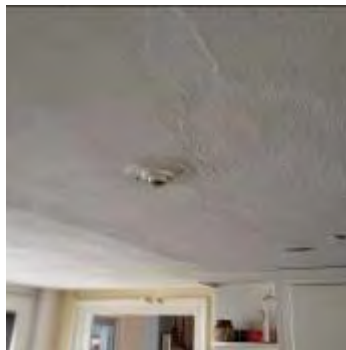
- The fire alarm system and intrusion system appear to share a Magnum Alert 1000 series common panel located in the basement. Smoke detectors exist in hallways and stairs. Heat detectors exist in the basement, attic, and kitchen. The facility does not have full coverage of detection and does not have horn/strobes. A knox box is located at the rear door.

Rating: 1

Heat in Kitchen

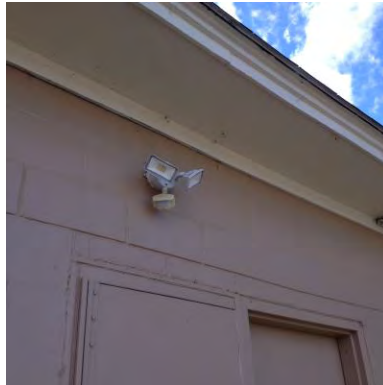
- The exterior lighting consists of a couple of building mounted LED mini-flood fixtures with integral motion sensors. The parking areas do not have pole lighting.

Rating: 1

LED Mini-Floods with PIR Sensor

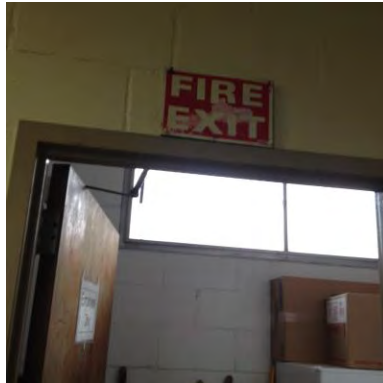
- The Exit signs consist of unlit signs. There are no battery units for emergency lighting.

Unlit Exit Sign

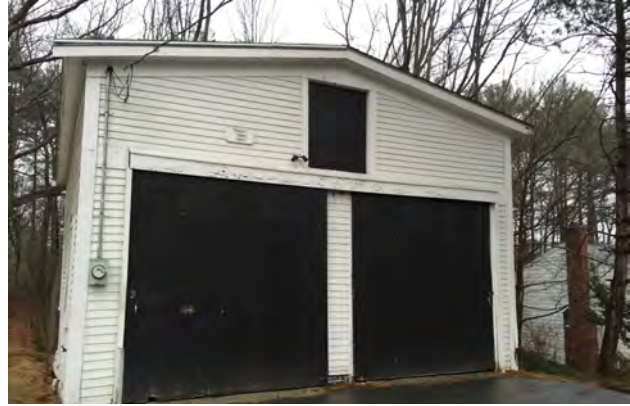
This is a small, historic wood framed building that shares a site with the Scalekeepers Office and Town Pound. The Moth House, also referred to as the Morse Barn, is currently being used for storage and provides a historic bookend at the northern edge of the Wilmington Center Village Historic District. The Moth House was only briefly assessed on the exterior due to the fact it is an unoccupied building of historic significance.

The exterior is painted clapboard siding which has many areas with rot or damage and requires repair. The building has asphalt shingle roofing which was not observed.

The building has electricity which is in poor condition and should be replaced. The building has no HVAC. Plumbing is limited to domestic piping which appears to be in fair condition.

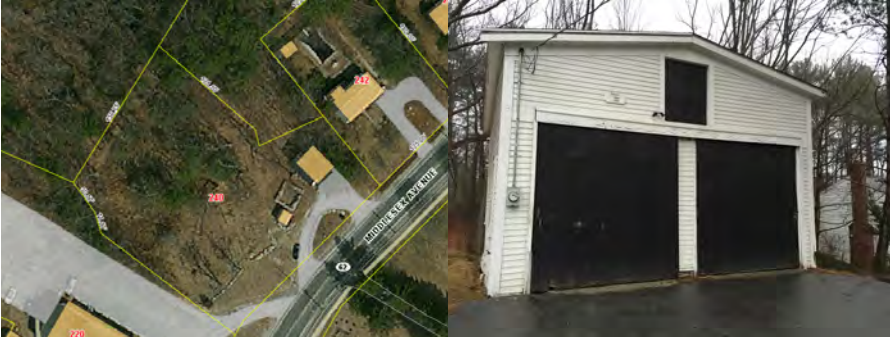
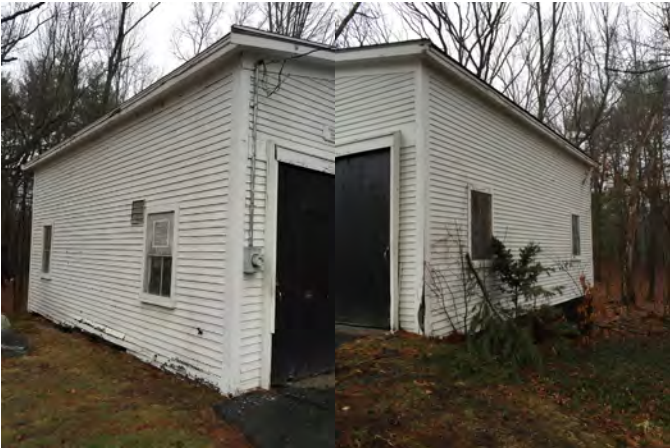
FACILITY PHOTOGRAPHS

- A ¾-inch domestic water service enters the building and is distributed to wall hydrants and internal hose bibbs. The domestic water piping is uninsulated or labeled. The isolation valves are original gate valves. There are no vacuum breakers on the wall hydrants and hose bibbs which makes them non-compliant. Overall, the domestic water is in fair condition.

The electrical systems for the Moth House are functioning but are in fair to poor condition. All existing electrical items should be replaced.
